Rotorua Lakes Council Wharf and Lakeland Queen Wharf Head Qualitative Assessment

Tonkin & Taylor Ltd. (T+T) has been engaged by Rotorua Lakes Council (RLC) to undertake an independent engineering assessment of the Council Wharf and Lakeland Queen Wharf Head (Berthage). The work was undertaken in accordance with T+T proposal "Rotorua Lakes Council Wharf and Lakeland Queen Berthage Engineering Assessment_v2" dated 17 March 2022.

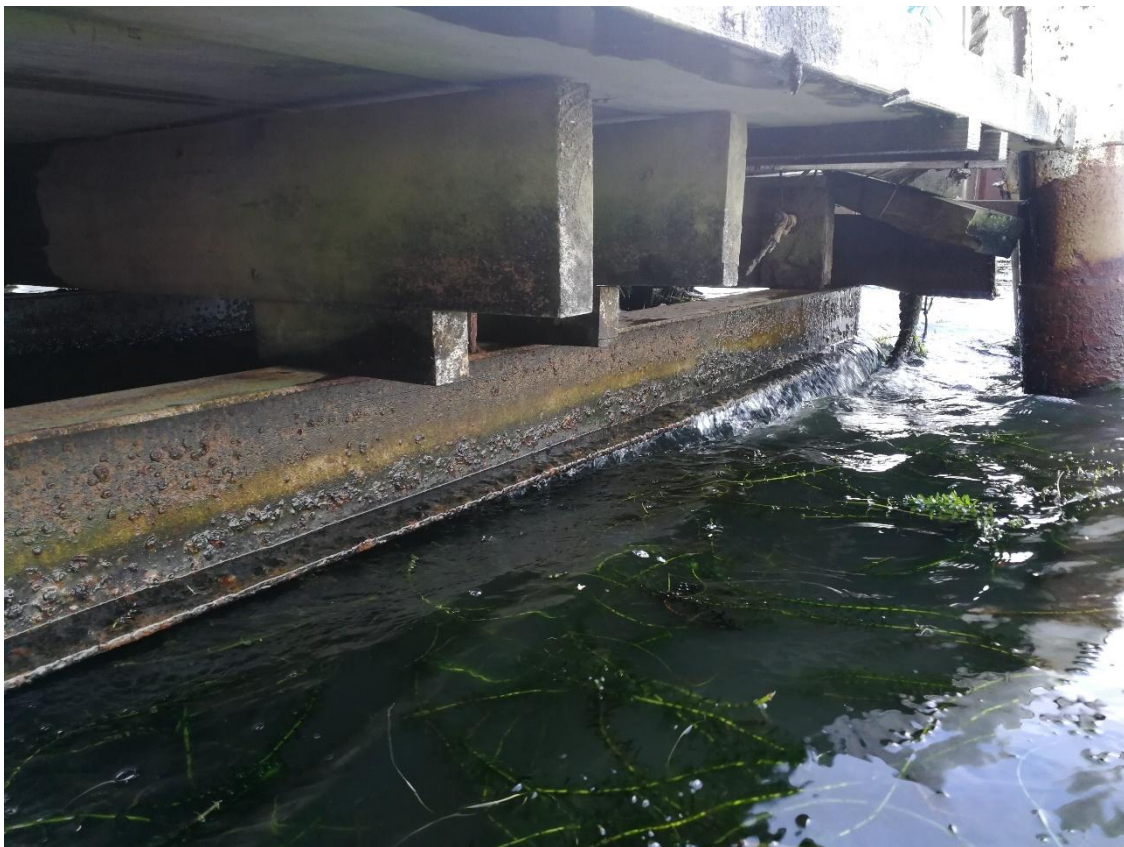
Photograph Appendix A.4: Lakeland Queen Wharf Head support structure- 2

- Timber joists located at the western end of the wharf head were placed on unsecured timber spacers (100 mm x 50 mm) and are likely to become unstable if subjected to lateral loads (Appendix A, Photograph A4).

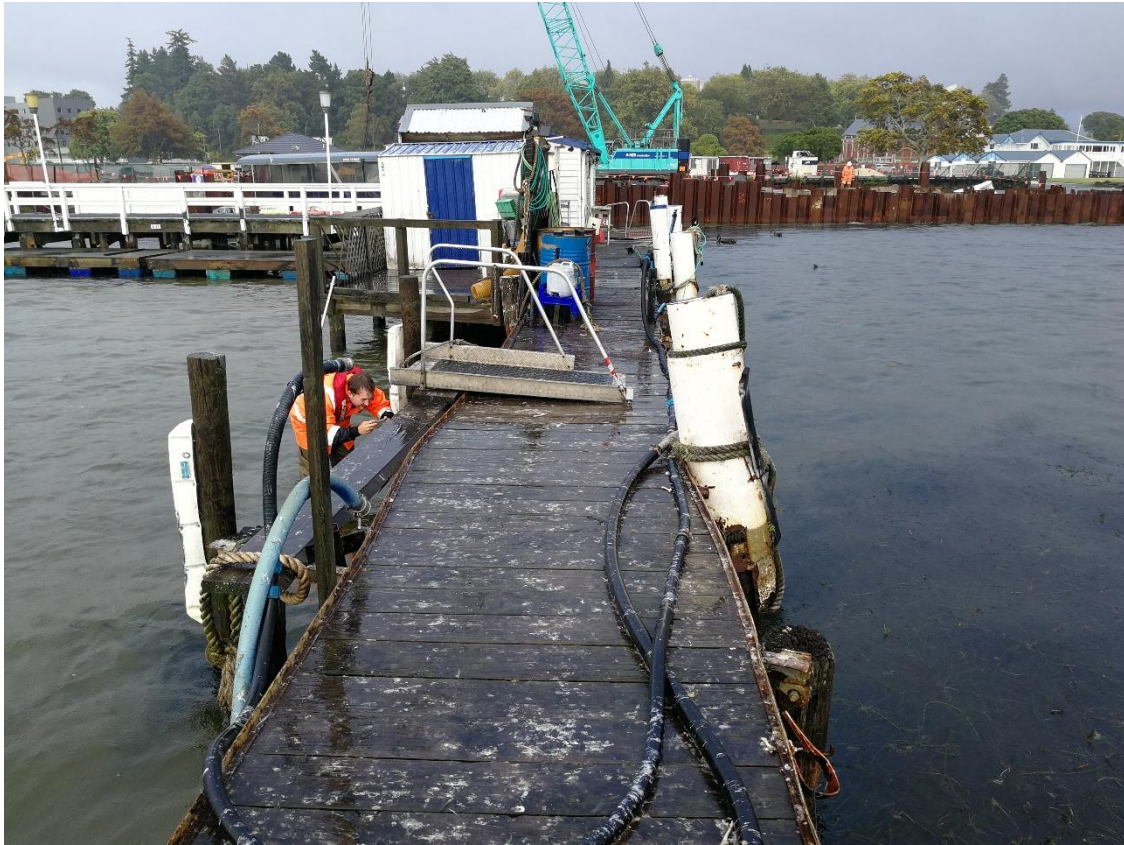
Photograph Appendix A.5: Lakeland Queen Wharf Head

- T+T's condition survey undertaken in 2005 (T+T ref: 15821.001) reported that the existing timber piles were on a tilt, a comparison of photographic records indicated that the tilting of the mooring piles have worsened since 2005 (Appendix A, Photograph A5).

- o The eastern end of wharf head section 1 has deformed. It appears to be caused by a mooring pile bearing on the wharf head. (Appendix A, Photograph A5)

- Some of the mooring piles connected to the wharf head resulted in lateral loads being transferred to the wharf head, and in some areas have resulted in deformation of the wharf head. It is likely that the wharf head will require straightening and strengthening to resist the applied loads. Alternatively, the mooring piles will need to be modified and strengthened to resist mooring loads to protect the wharf head.

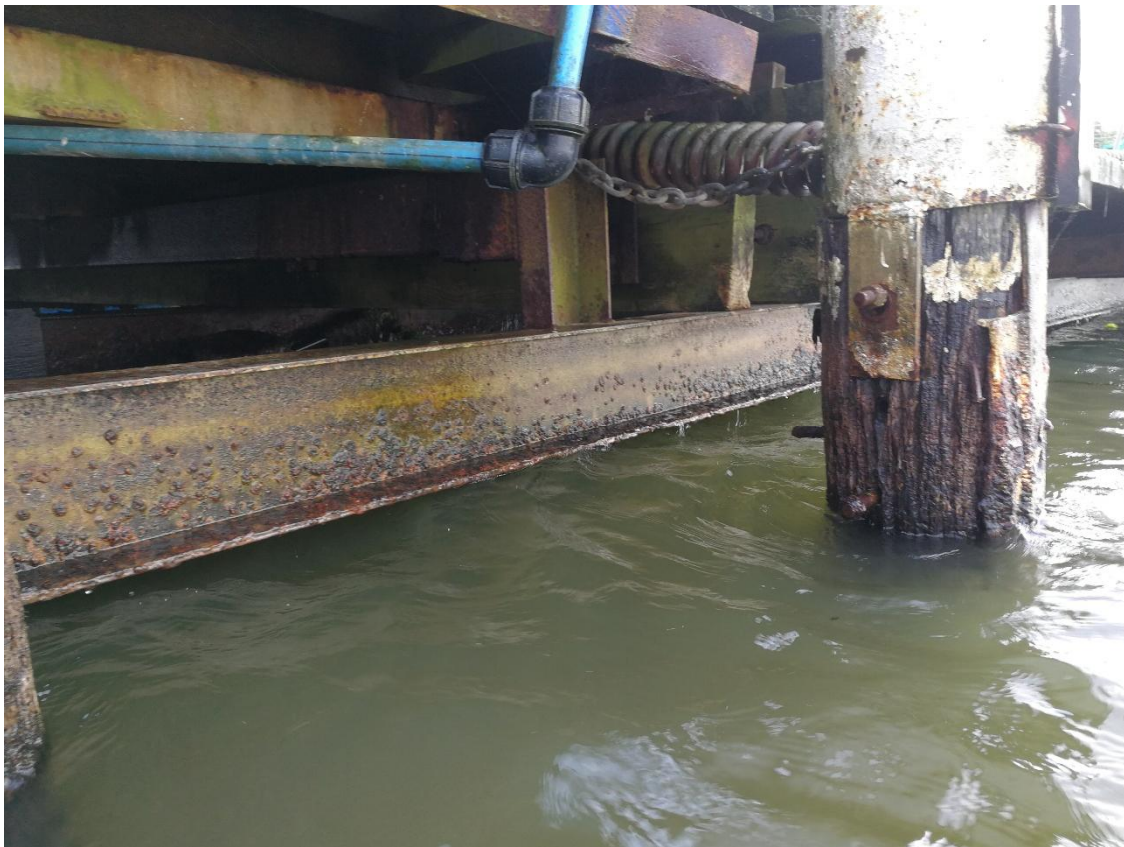
Photograph Appendix A.6: Lakeland Queen Mooring Pile

- o A timber pile directly in front of the freezer/cooler shed appears to have been converted to a mooring pile by attachment of a steel tube on top of the existing timber pile. The converted mooring pile is connected to the wharf head with a spring. Such modification increases the applied loads to the wharf head and may damage the wharf head. (Appendix A, Photograph A6)

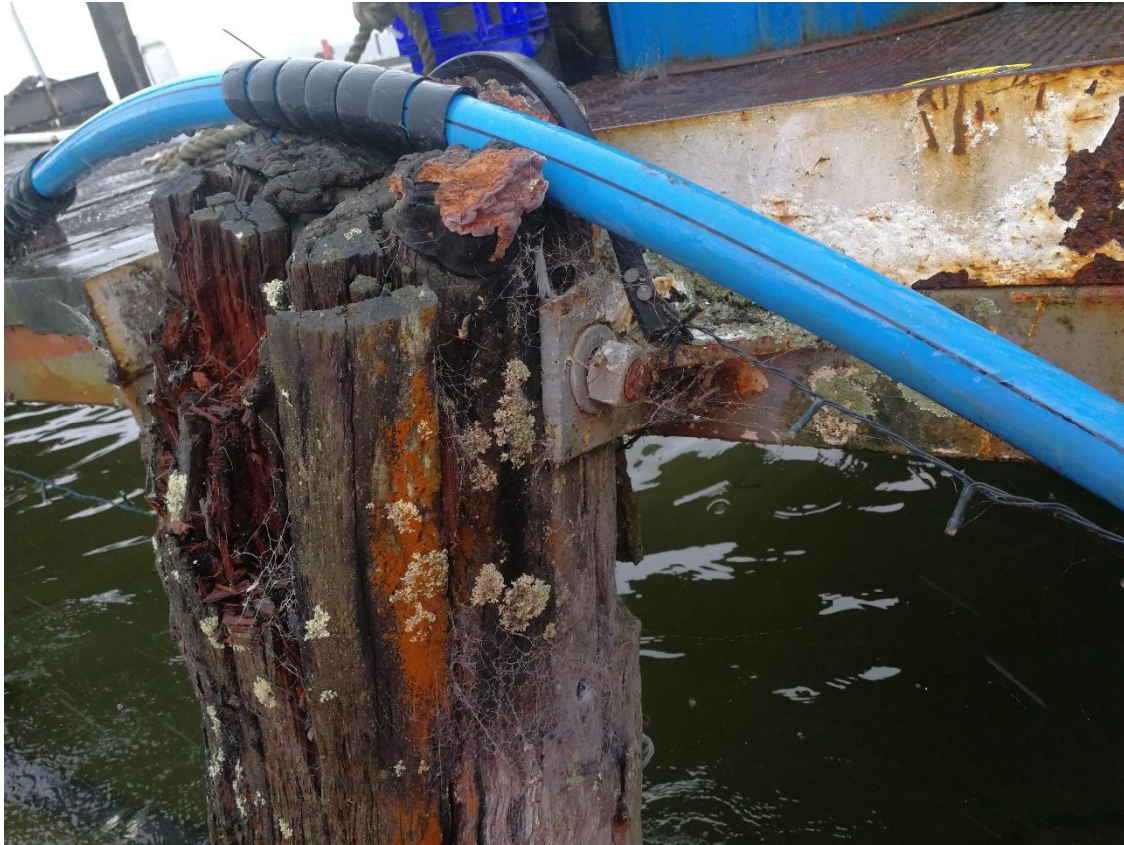
Photograph Appendix A.7: Lakeland Queen Wharf Head pile - 1

- The wharf head timber piles are generally in unsatisfactory condition. Some of the wharf head piles were capped with a steel cap and therefore their condition could not be visually examined. However, piles that were visible showed signs of severe rotting. Areas with the most significant rotting, were pile ends and areas subjected to water to air interface (Appendix A, Photograph A7 and Photograph A8).

Some timber piles have rotted severely at locations around the wharf head - timber pile bolted connections. The integrity of these connections is compromised, and they are unlikely to fulfil their original intended functions. (Appendix A, Photograph A7)

- At the completion of all repair works, all steel members should be cleaned free of rust and contaminations and coated with protective coatings.
- The timber wharf head piles appear to have either reached or are close to reaching their design life, based on the level of observed rotting. Though the timber piles have not rotted through its cores, the rotting will likely be ongoing, and are unlikely to be sustainable in the long term. Replacement of the existing wharf head timber piles or installation of additional new timber piles to support the wharf head is recommended.

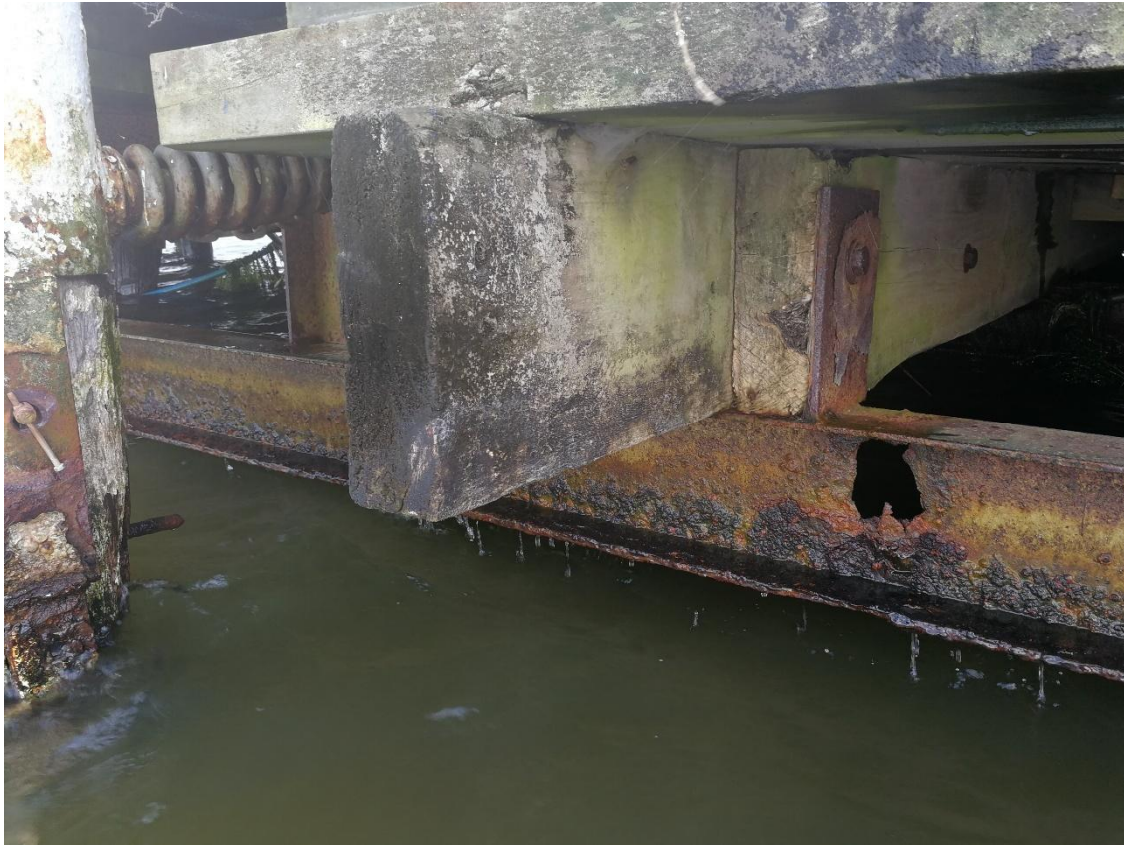
Photograph Appendix A.9: Lakeland Queen Wharf Head 200 UB edge beam

- The lakeward 200 UB steel edge beam is severely corroded, and it was noted that a small part of the web has fully corroded through. (Appendix A, Photograph A9)

- The corroded steel substructure should be remediated as a matter of urgency as these are the main members supporting the superstructure. Severely corroded members, in particular the 200 UB steel edge beams, should be replaced. Decking may need to be temporarily removed, and the wharf head may need to be temporarily jacked up to undertake the repair.

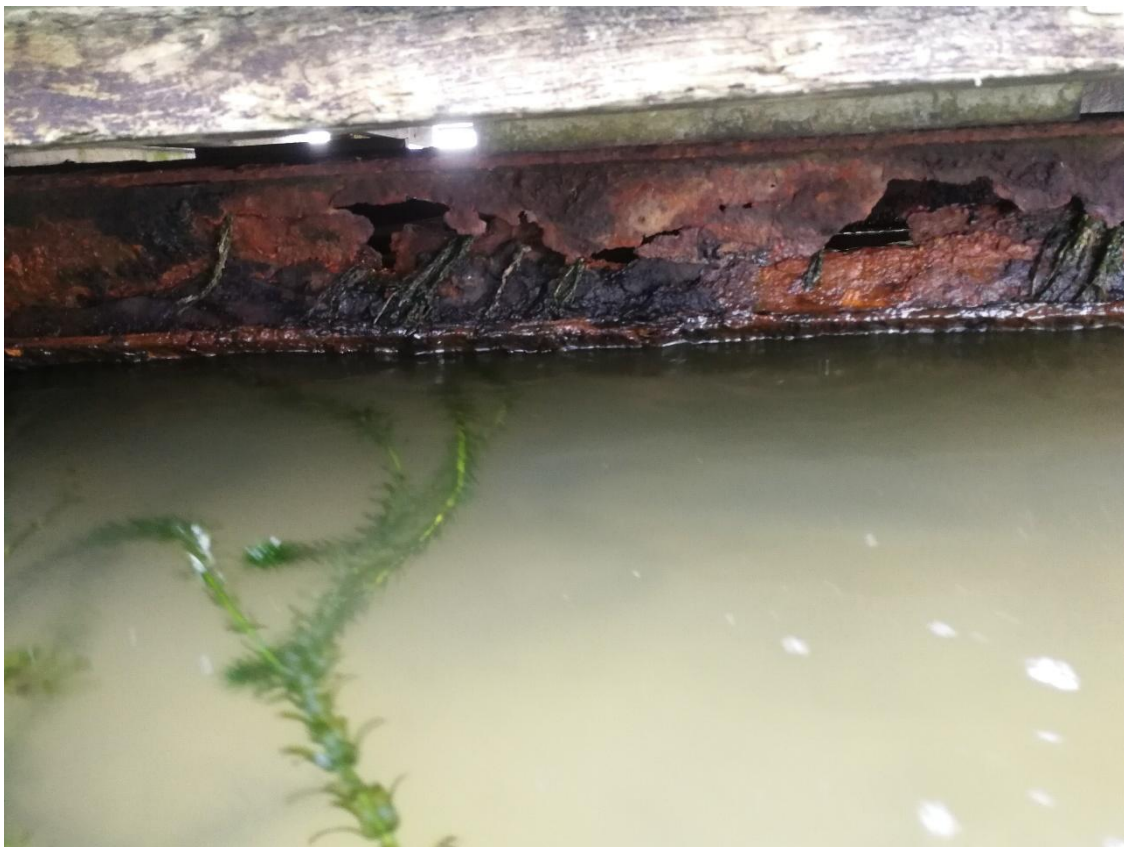
Photograph Appendix A.10: Lakeland Queen Wharf Head 200 UB edge beam

- The landward 200 UB steel edge beam (directly below the freezer/cooler shed) is also severely corroded and a significant section of the beam has completely corroded, causing the member to collapse. (Appendix A, Photograph A10)

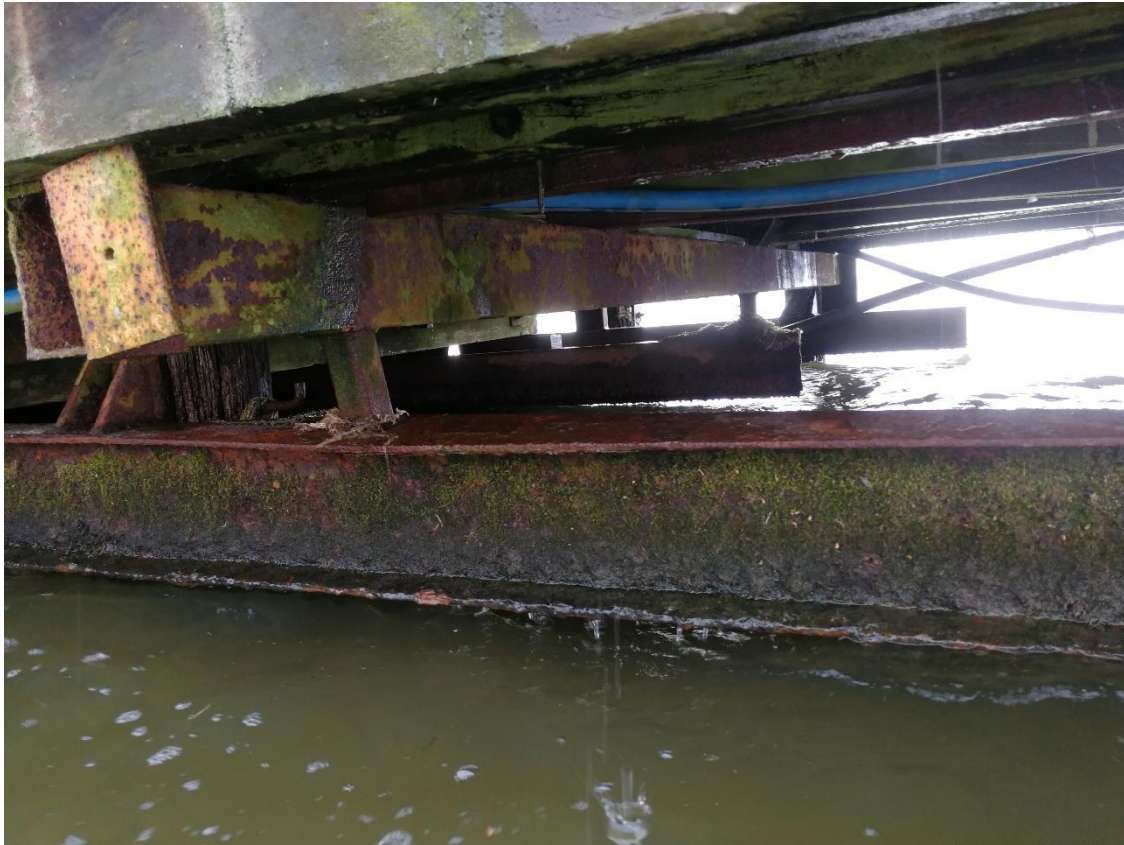
Photograph Appendix A.11: Lakeland Queen Wharf Head support structure

- Some of the rectangular hollow section joists showed signs of severe corrosion on the outside, though the inside of these sections could not be inspected, it is likely that the severity of corrosion on the inside face will be similar to that of the outside, given the ends of these members are usually unsealed. (Appendix A, Photograph A11)

- Steelwork with moderate level of corrosion should be cleaned off and undergo thickness testing to establish remaining thickness of members. Members with significant material loss should either be repaired or replaced.
