**Subject:** FW: Some findings from the test bores at the sala cemetery  
**Attachments:** ECM\_19936995\_v3\_Rotorua Cemetery bore holes testing August 2023.docx

## Rotorua Cemetery – Water Table Test Bore Investigation

Dated: 14 August 2023

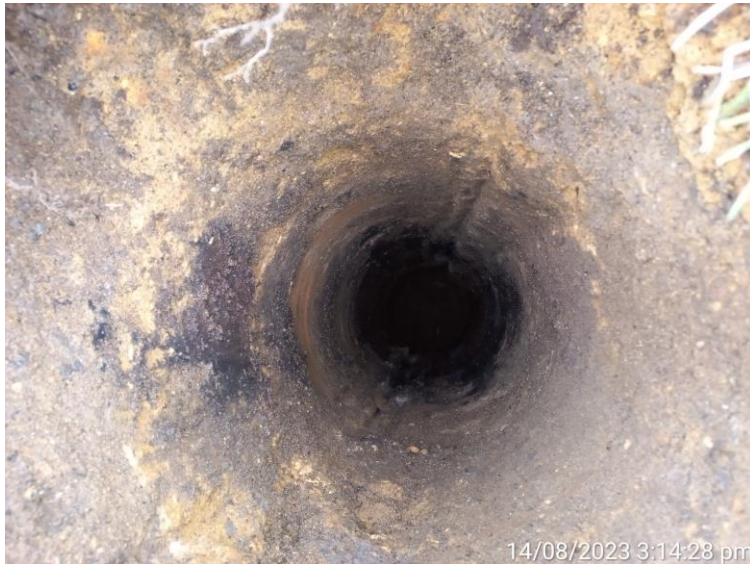
### Hole 1

Initial hole picture. No sign of water egress or wet soils.

Depth 2m, Ambient temp 15.8 degrees and no gas emissions recorded.

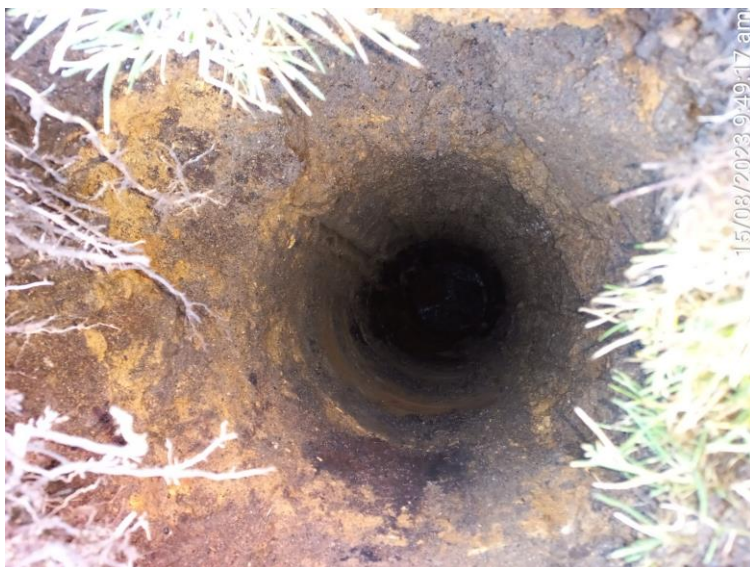
Follow up photo next morning

No sign of water egress into hole.

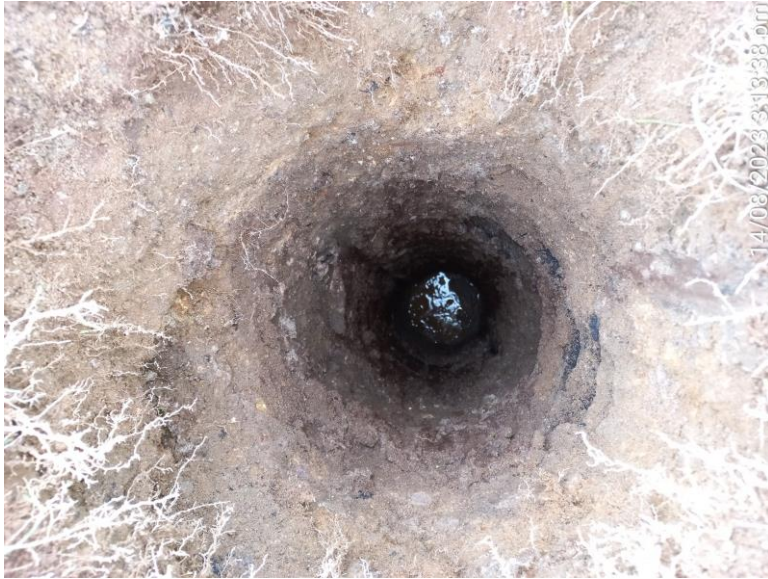
## Hole 2

Initial hole picture. Water present in bottom of hole. 250mm of wet muddy soil retrieved from bottom of hole during drilling operation.

Depth 2m, Ambient Temp 17.8 degrees and no gas emissions recorded

My thoughts on these findings are that it would be challenging to dig a double depth plot given the lower bore section was wet and muddy in two of them. This would make stopping the grave from collapsing without shoring difficult and if there had been a period of wet weather prior to this then potentially the coffin would be sitting in water at the bottom of the grave near sites two and three.

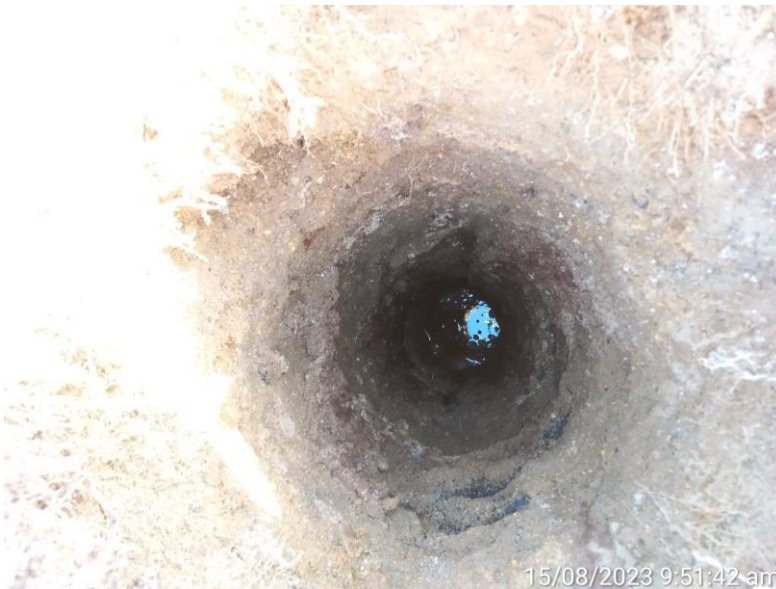
The water table this morning in these two holes was 1.85 and 1.82m below the surface. A standard grave needs to be 2m deep.

Follow up photo next morning

Water present in bottom of hole – depth recoded at 150mm.

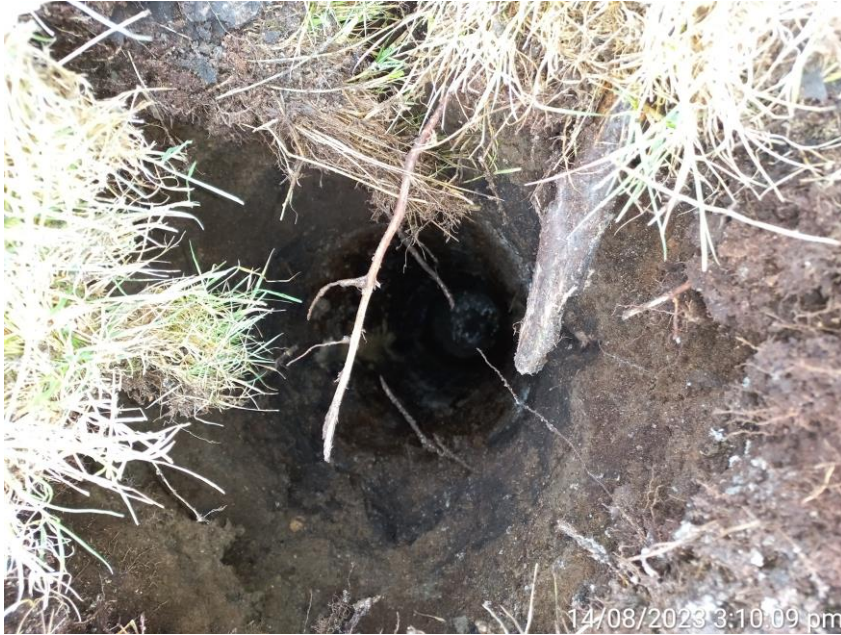
### Hole 3

Initial hole picture. Water present in bottom of hole. 350mm of wet muddy soil retrieved from bottom of hole during drilling operations.

Depth 2.1m Ambient Temp 20.3 degrees and no gas emissions recorded

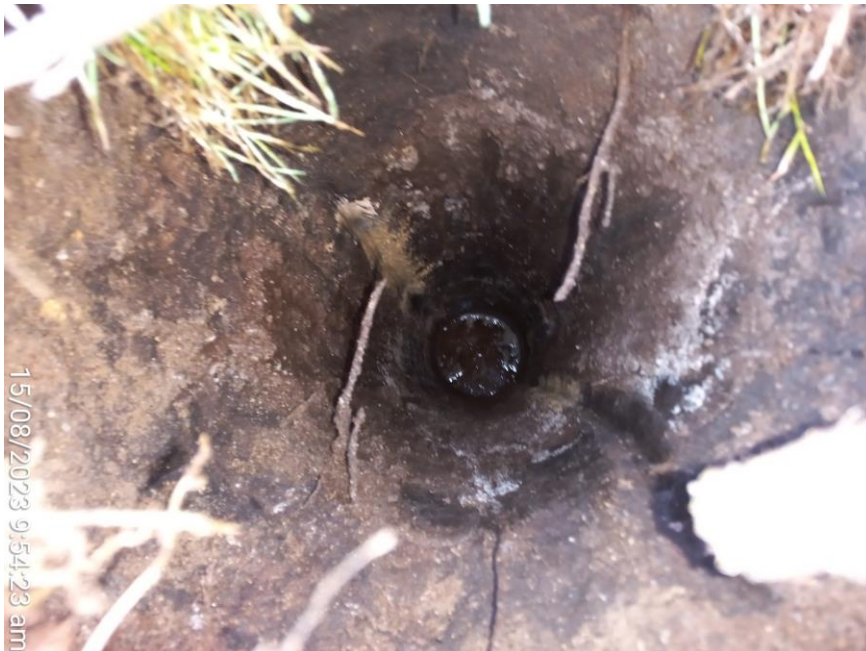
Follow up photo next morning

Water present in bottom of hole – depth recorded at 185mm.
