Bay of Plenty Regional Active Fault Mapping for Growth Areas

**GNS Science Consultancy Report 2018/143
March 2019**

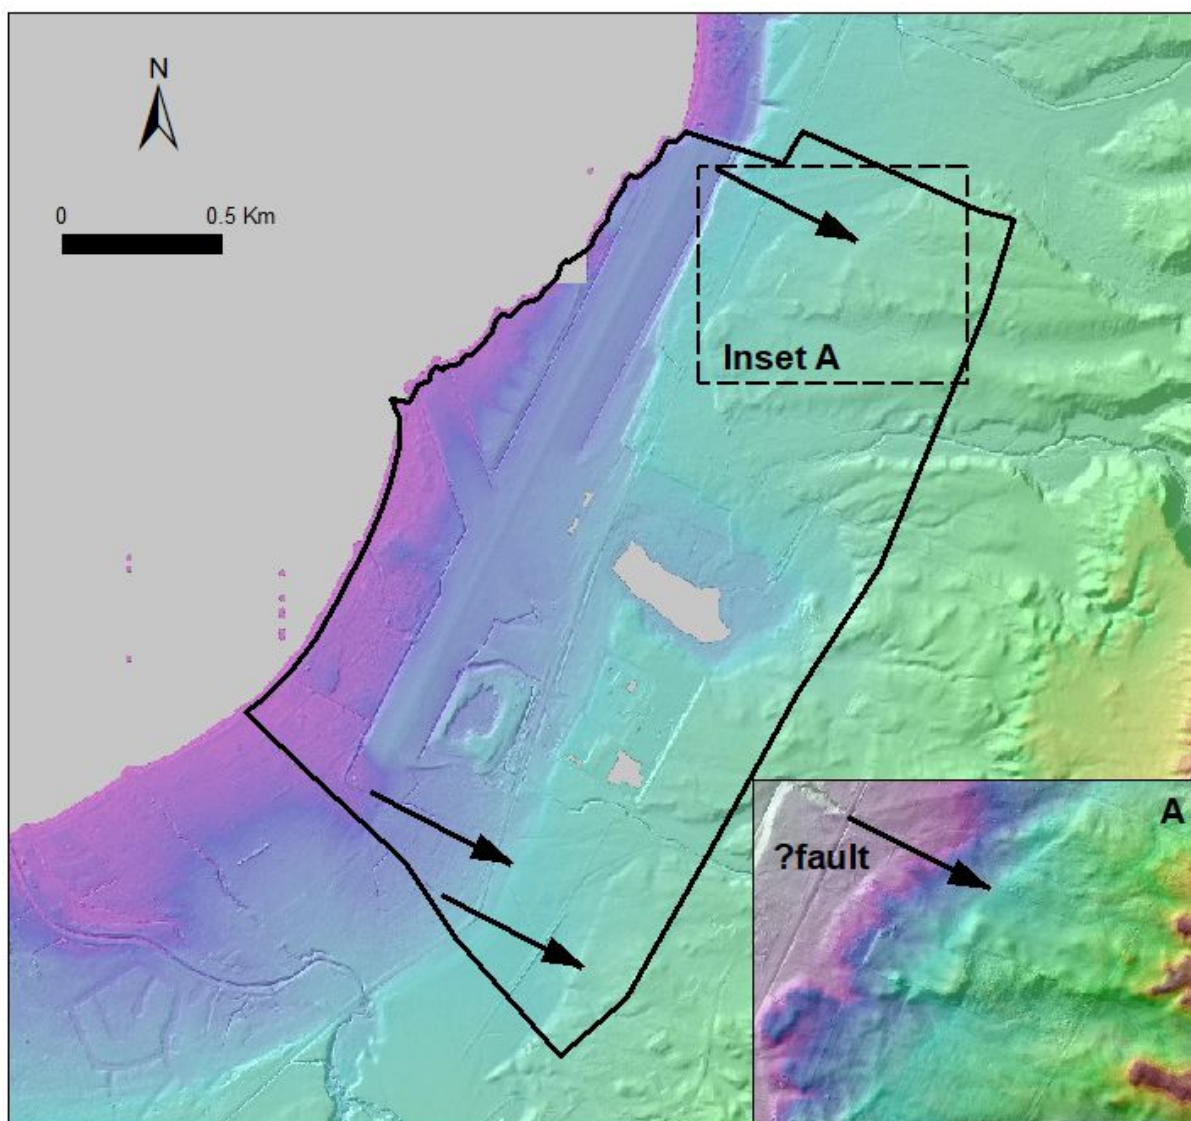
In the northern part of the Airport we did identify one topographic scarp as a possible active fault, but further investigation showed this was unlikely. The inset map of Figure 5.6 shows the scarp that we studied in more detail. We have concluded the scarp is most likely to be an old, poorly preserved and highly dissected lake shoreline (see Figure A3.1). We examined the height contours around the lake and it is possible that this feature correlates to other shoreline features at the same height around the north shore of the lake and that correspond with a shoreline form between 36,000 to 27,000 years ago (see Appendix 3; Figure A3.1). The shoreline at this elevation is not well preserved at any location, perhaps indicating the lake level was only at this elevation for a relatively short period of time, inhibiting the formation of a prominent shoreline scarp. This is likely the reason why this shoreline is not mentioned in the literature, as it would have been difficult to map without LiDAR derived high resolution maps.

Figure 5.6 Shorelines (unlabelled arrows) are clearly seen from LiDAR data. Inset A shows a sharp line that is likely to be an old dissected lake shoreline. For more details on shorelines see Appendix 3.

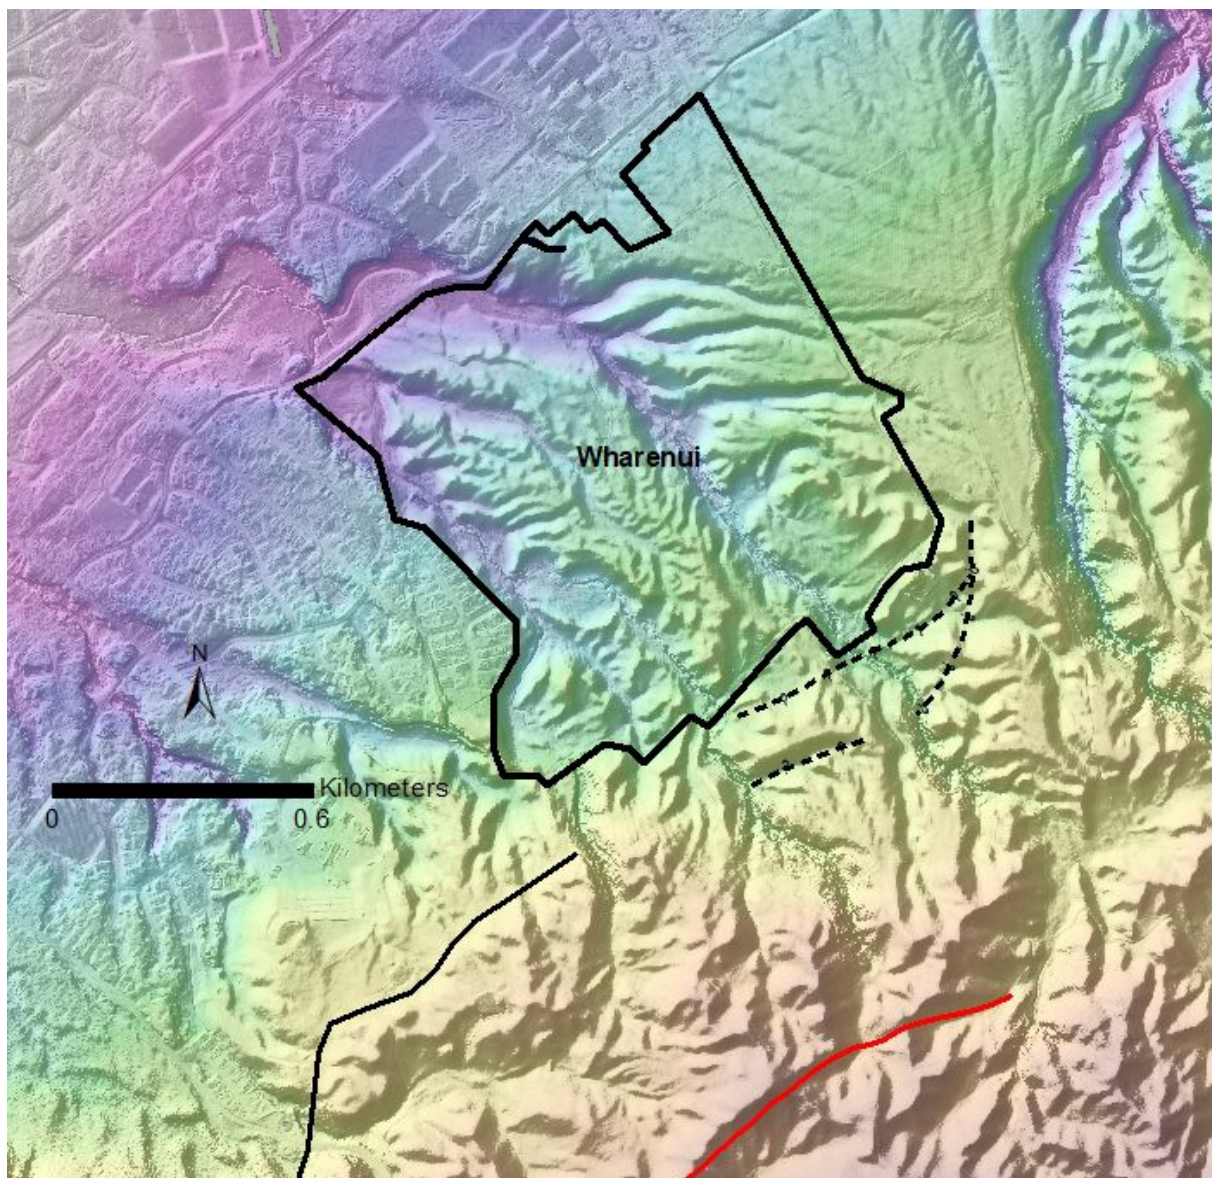
Within the Wharenui site, there is no evidence of any active faults (Figure 5.7). The landform surface in the Wharenui area is relatively old and is a highly dissected surface underlain by pumiceous fluvial and lake deposits aged ~12,000 to 186,000 years based on Leonard et al (2010), but could be more constrained 27,000 to 60,000 based on our compilation of shorelines (see Appendix 3; Figure A3.1). Approximately 1 km to the south of the Wharenui site, a possible east-northeast trending active fault has been identified (Figure 5.7). Subtle topographic lineations immediately southeast of the site boundary (dashed lines, Figure 5.7) may relate to the mapped active fault that lies southwest but these do not cross into the Wharenui site footprint.

Figure 5.7 LiDAR DEM of the Wharenui site shows an absence of active fault scarps. An active fault trace (red line) lies about 900 m southeast of the site but trends away from the area. An inactive fault (black solid line) trends to the northeast and may correlate to the lineations identified in the LiDAR (black dashed lines).

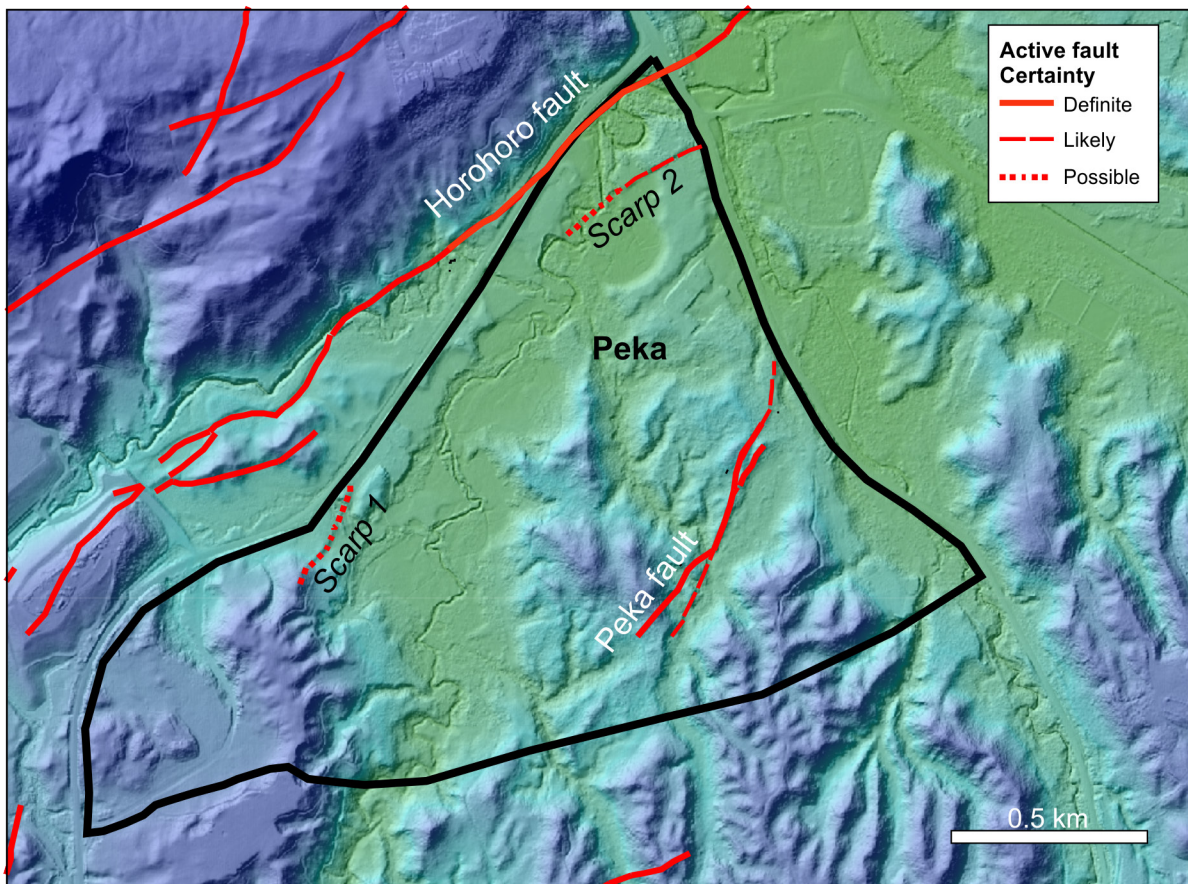
On the eastern side of the Peka site is an unnamed fault scarp, previously identified by Villamor et al. (2010). We informally name this the Peka fault and our fault mapping agrees with Villamor et al. but we extend the fault scarp about 100 m further to the northeast. We place a FAZ around the Peka fault, but no data is available to assess the slip rate and RI of the fault. We suggest the fault is likely to have a similarly low, or lower, slip rate as the Horohoro fault (<0.17 mm/yr) and a similarly long, or longer, RI (>7400 years), therefore it is an RI Class IV fault. Reasons to suggest the Peka fault has an equal or lower rate of fault activity to the Horohoro fault are based simply on the poor preservation and short surface traces of the Peka fault scarp. Two other short (<500 m) fault traces have been identified in the Peka site (Scarp 1 and Scarp 2, Figure 5.8). From such short traces it is difficult to assess the likelihood that these scarps are active faults, so we assign them “likely” and “possible” certainties. As with the Peka fault, we suggest these are treated as RI Class IV faults; these scarps may be part of the Horohoro fault zone.

Figure 5.8 Active faults (red lines) around and within the Peka development site. Each fault trace has an assigned certainty which reflects the confidence we have that the feature is an active fault scarp.

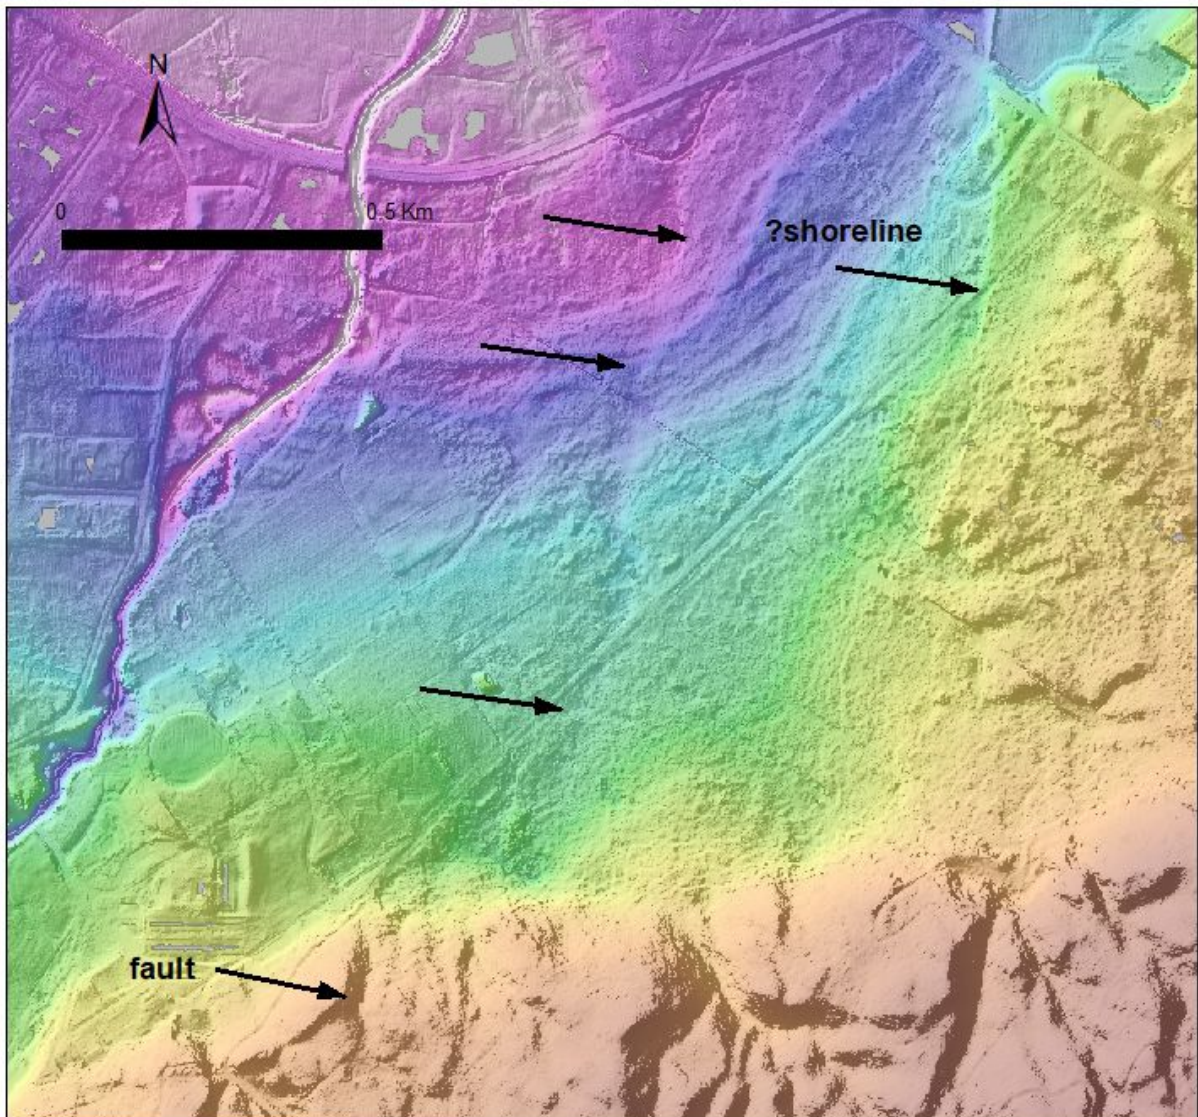
Figure A2.1 Lineations identified from LiDAR data (see Inset B in Figure 5.3) that trend northwards in the direction of the Eastside development site. The feature labelled "fault" is identified as a fault trace. The unlabelled arrows highlight a lineation that may possibly be a fault. The sharp lineation on the right may be a shoreline.
