Development Options Puarenga & Neil Hunt Parks

Rotorua Lakes Council

Client:	Rotorua Lakes Council	
Project:	2020 Development options – Puarenga & Neil Hunt Parks	
Report published:	11 September 2020	
Author:	David Ormsby	dormsby@nzsti.org.nz
Position:	Regional agronomist	0274 428053
Disclaimer:

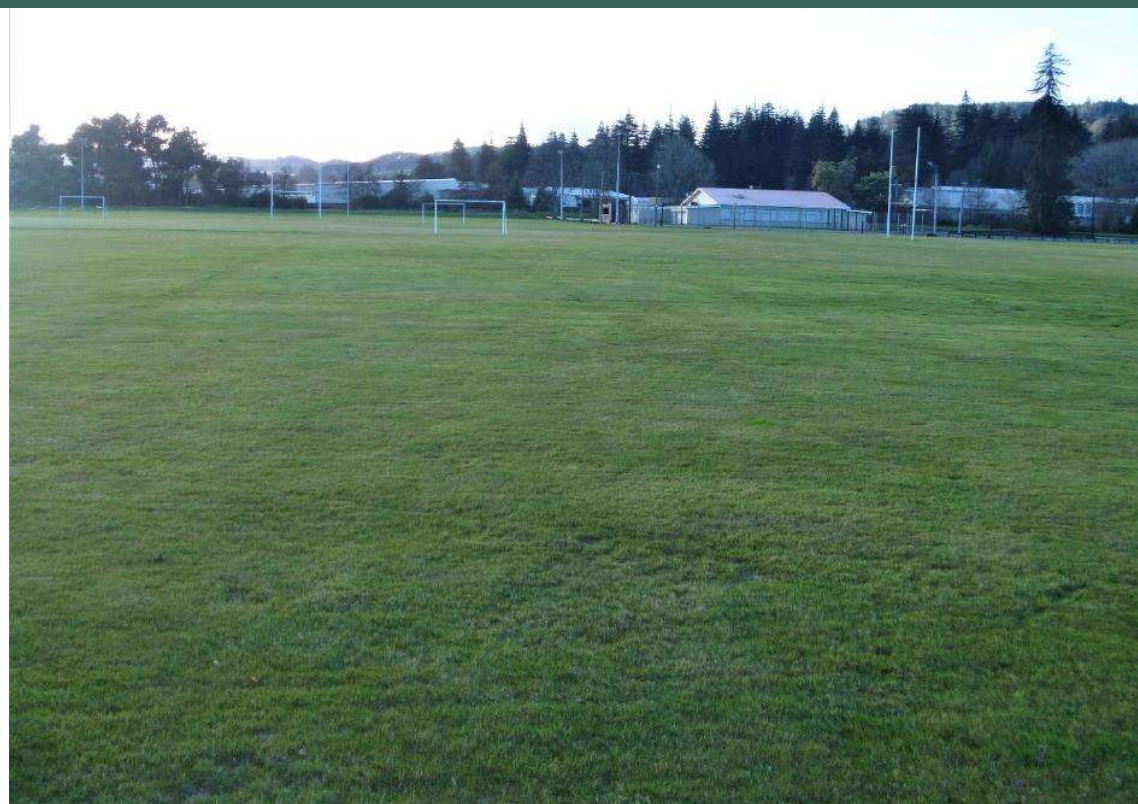
Puarenga Park

1. Regional Council nutrient cap
2. Geothermal activity
3. Grass type
4. Drainage (localised)
5. Micro -levels

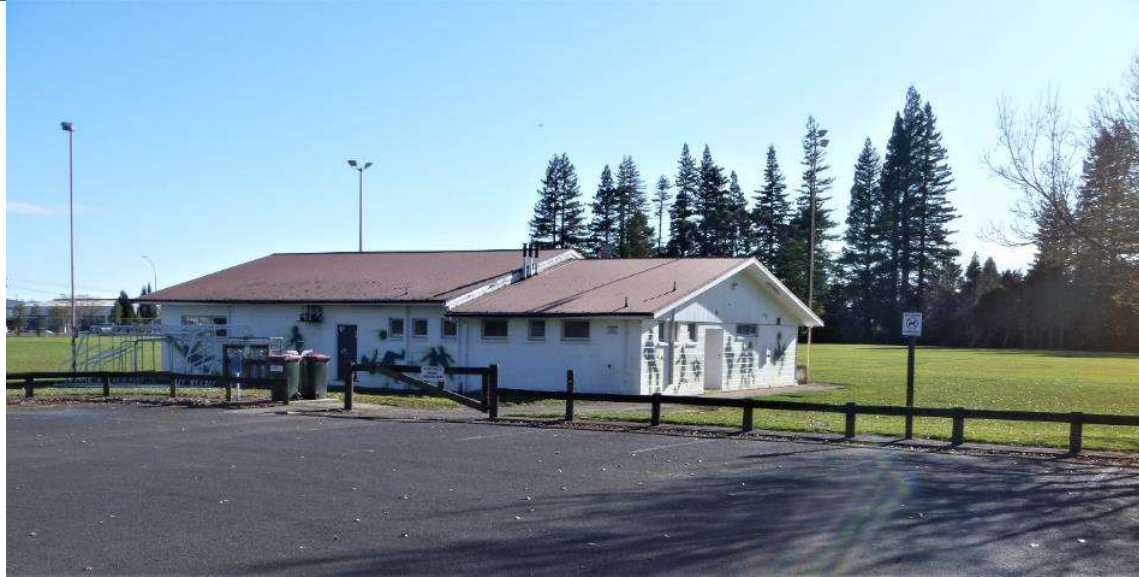
Neil Hunt Park

1. Micro levels
2. Maintenance
3. Drainage
4. Sub profile sawdust/trees

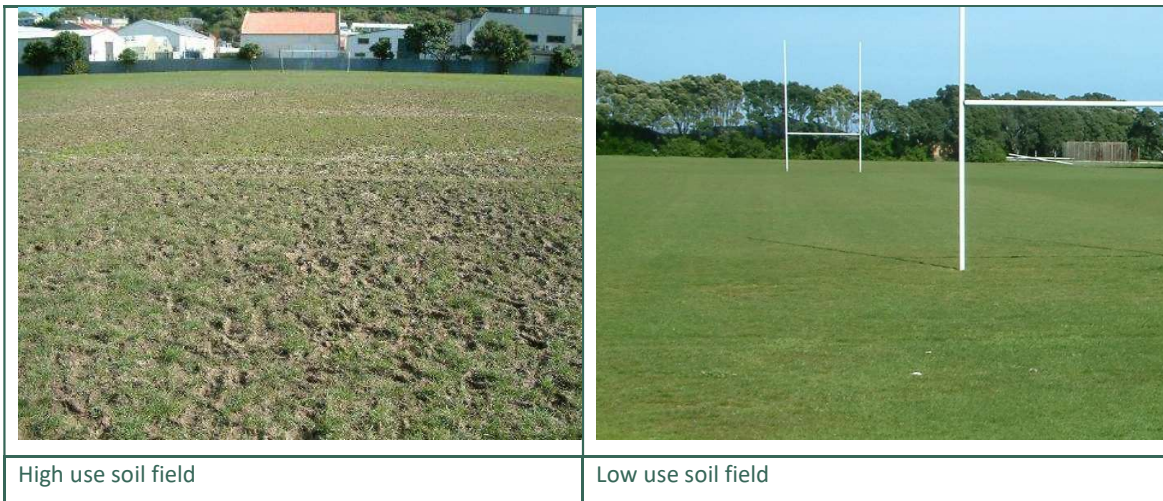
A soil/sand field can tolerate any amount of use, providing quality is not a consideration. Where a quality outcome is required use on all surfaces must be managed. Typical guidelines show that once adult use exceeds 10hrs use per week during winter/summer when growth is limited on cool season grasses, field quality will start to deteriorate (loss of cover, muddiness issues on soil etc). In saying this it is not uncommon to see natural fields tolerating 15 – 20hrs adult use/week.

Consequently, when considering models for hours use, they need to be related to the desired quality of the field surface.

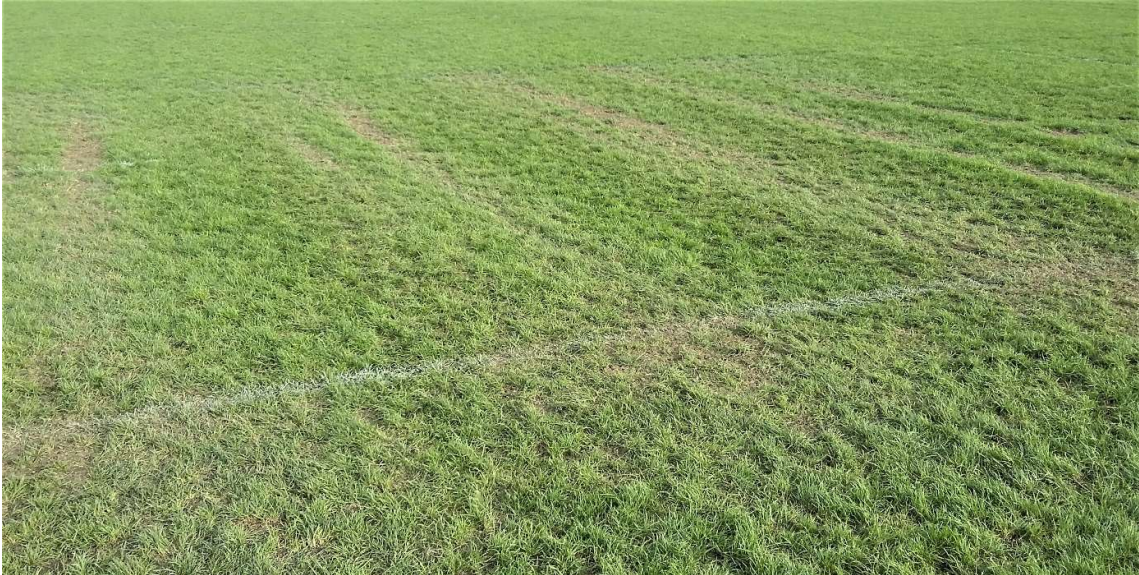
Figure 1. Wear caused by 1 hrs practise doing shuttle runs.

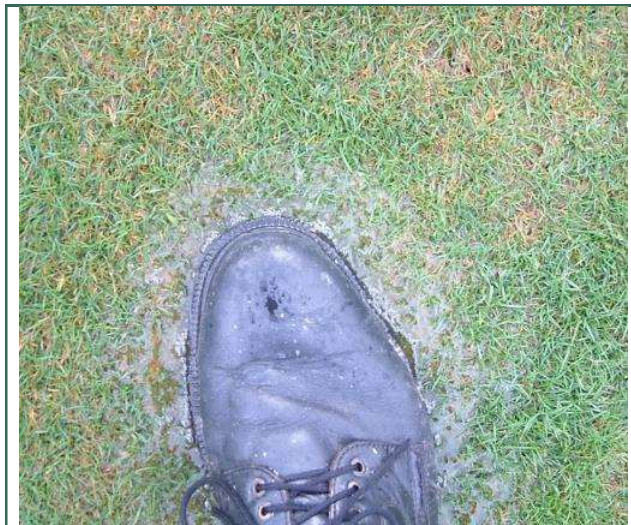
Excluding No.9 field, all fields have a substantial thatch (20 – 30mm deep) layer which holds water in the surface.

First emphasis should be on managing thatch and maintaining water movement through the topsoil to the underlying free draining pumice subgrade. Ideally this would involve increasing your present aeration programme, notably:

- Solid tyne verti-draining: April, May, June
- Spiking (groundhog): July, August

- Hollow tyne coring and liming: September
2. Priority two: slit draining/sand topdressing
Where drainage is limiting use of the Park, then secondary drainage (slit drain, gravel banding) coupled with a sand topdressing programme is recommended to provide a link with the surface and freer draining subgrade.
Note Slit draining was installed in southern area around the geothermal zone in 2012. I suspect this has been compromised with the new service road.
 3. Sand carpet
Given constraints around fertiliser use, geothermal activity the sand carpet concept is not recommended. The basis for this is that given these constraints I do not believe you will achieve additional use over what is presently occurring.

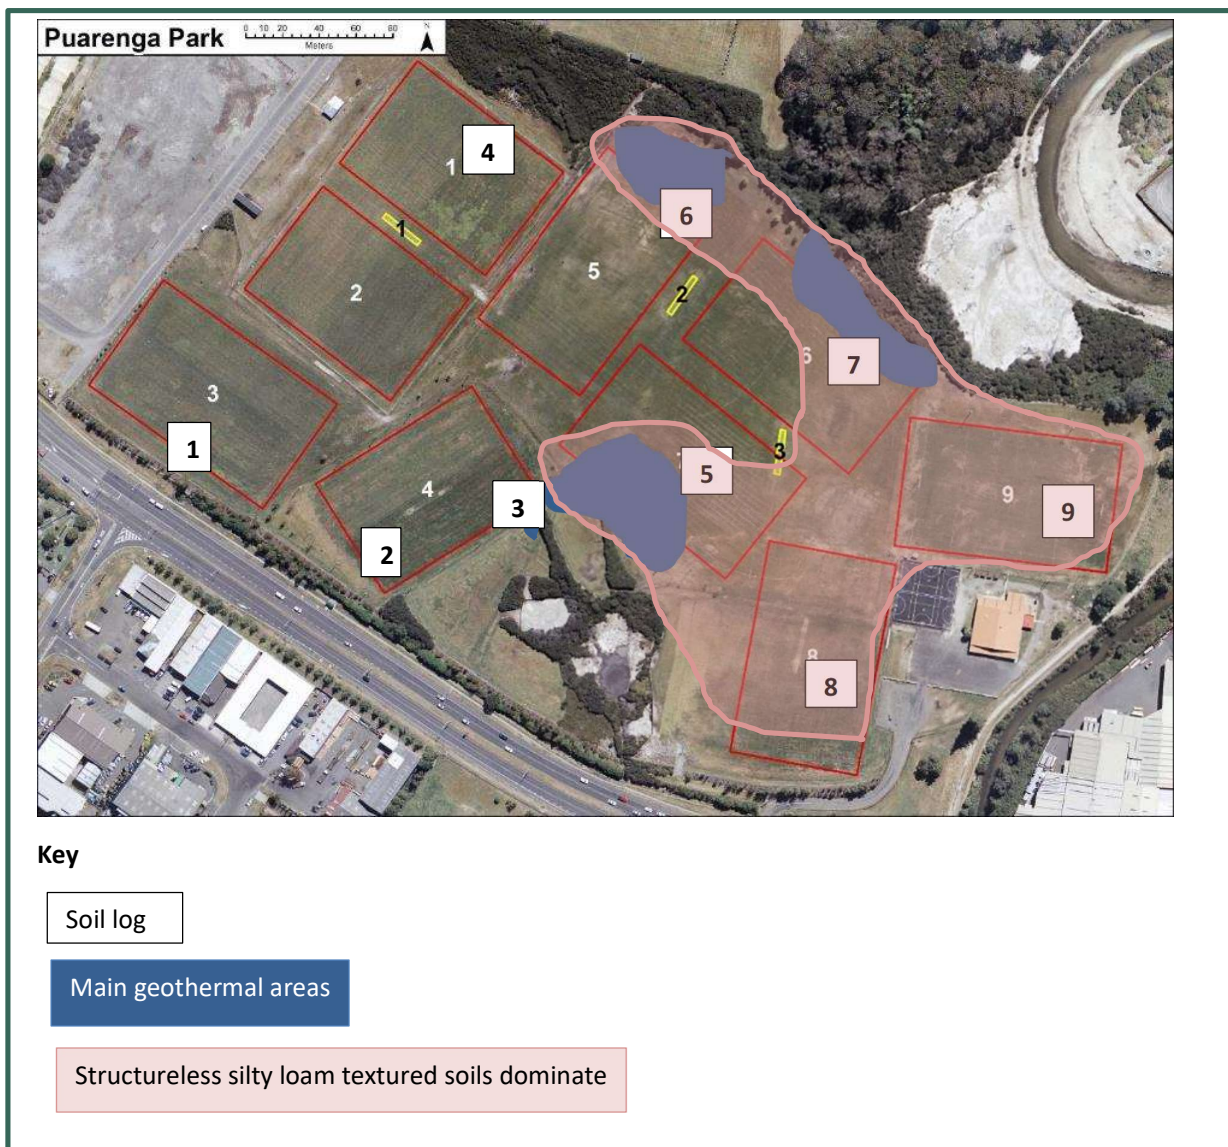
1.1.14 SITE ASSESSMENT

- Extensive thatch development (20 – 30mm deep) which holds moisture, particularly over winter
- East and south, 125 - 150mm (approx.) poorly structured silt loam textured topsoil – poorer drainage
- North/central area 125 – 150 sandy loam – above average drainage
- Topsoil overlies various grades of pumice which offers reasonable drainage.

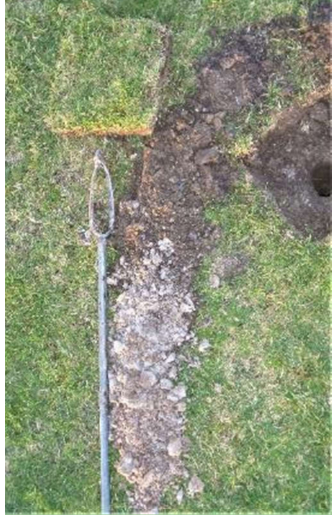
<ul style="list-style-type: none"> • 0 – 25mm Thatch – drainage = average to below average • 25 – 125 sandy loam – drainage (good) • 125 – 300 sandy loam/pumice mixture drainage = good • 300 – 700 – fine pumice drainage = good

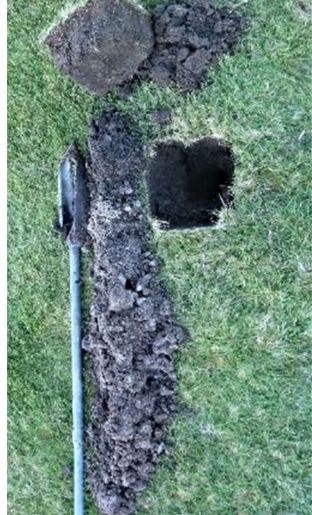
<ul style="list-style-type: none"> • 0- 25mm thatch drainage = average to below average. • To 300mm - sandy loam drainage = good • 300 to 500 pumice soil mix drainage = average • 500 to 700 pumice sand drainage = excellent • Water table at 600mm

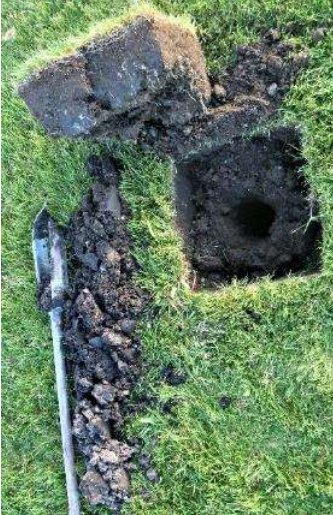
<ul style="list-style-type: none"> • 0 – 25mm thatch drainage = average to poor • To 250 silty loam drainage = poor • 250 to 500 pumice soil mix drainage = poor • Soil very wet at 500mm
<p>Figure 2. Soil log 1</p>		<p>Figure 3. Soil log 2</p>		<p>Figure 4. Soil log 3</p>

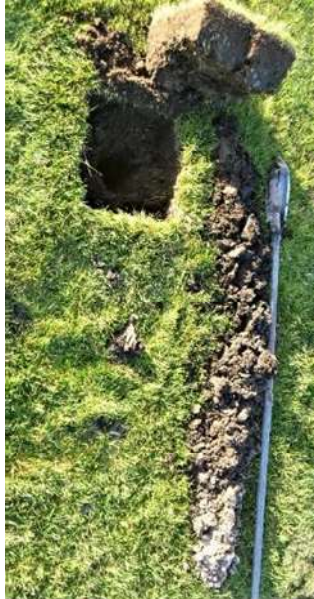
<ul style="list-style-type: none"> • 0 – 25mm thatch drainage = average to below average • To 250mm – sandy loam drainage = good • 250 – 600 volcanic mud/pumice drainage = poor wet at 500mm

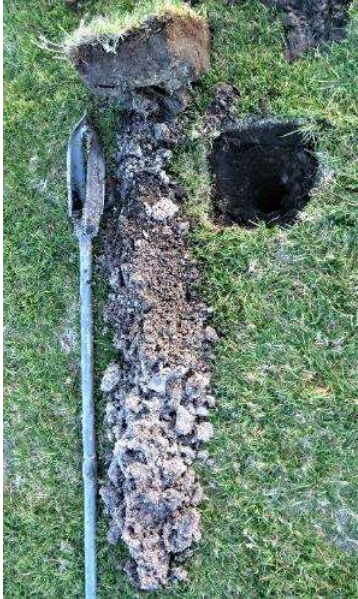
<ul style="list-style-type: none"> • 0 -30mm thatch drainage = below average • To 200 silty loam (mottled) drainage = poor • 300 to 700 fine pumice drainage = average • Water table at 700mm

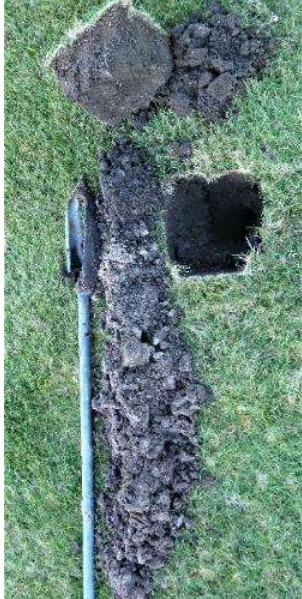
<ul style="list-style-type: none"> • 0 – 30mm thatch drainage = average to below average • To 250mm silty loam drainage = poor • 250 – 700mm pumice drainage = good • Water table at 700mm
<p>Figure 5. Soil log 4</p>		<p>Figure 6. Soil log 5</p>		<p>Figure 7. soil log 6</p>

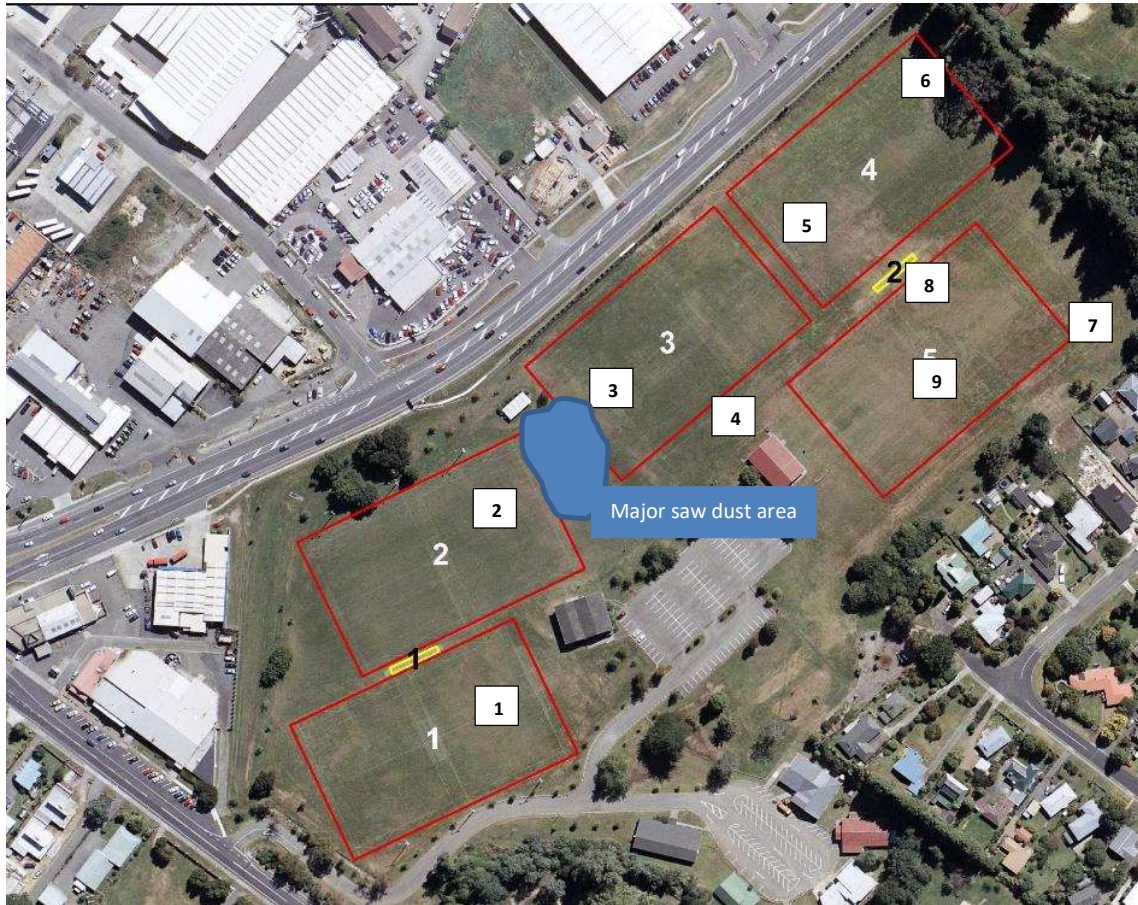
1.1.15 SITE ASSESSMENT

Soil log	Description	Soil Log	Description	Soil log	Description
 	<p>Soil log 1</p> <p>0 – 150 Sandy loam average drainage</p> <p>150 – 350 pumice – good drainage</p> <p>350 – 500 – fine pumice good drainage</p> <p>500+ coarse pumice excellent drainage</p>		<p>Soil log 2</p> <p>0 – 150 Sandy loam average drainage</p> <p>150 – 500 pumice – good drainage</p>	 	<p>Soil log 3</p> <p>0 – 200 sandy loam average drainage</p> <p>200 – 600 fine pumice good drainage</p> <p>600+ sawdust</p>

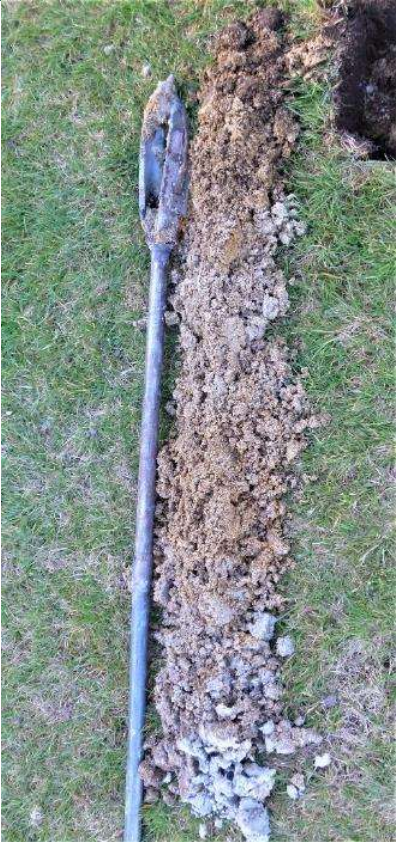
<p>Soil log 4</p> <p>0-200 sandy loam average drainage – severe surface sealing</p> <p>200 – 600 pumice good drainage</p> <p>650 Tree trunk</p>

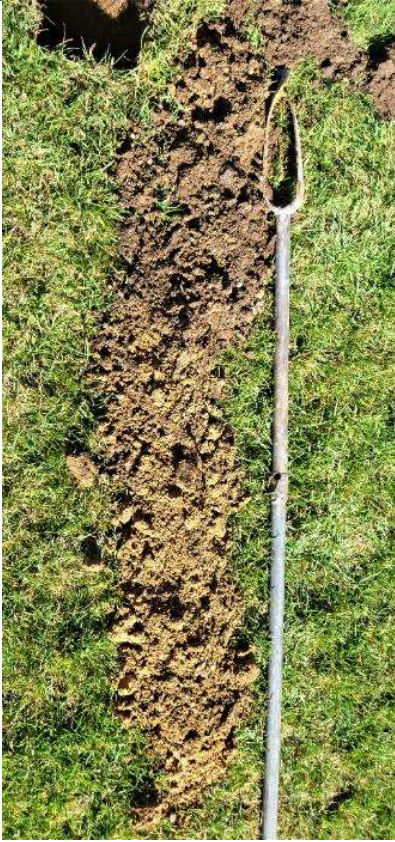
<p>Soil log 5</p> <p>0-150 sandy loam average drainage</p> <p>150 – 750 pumice good drainage</p>		<p>Soil log 6</p> <p>0 – 150 sandy loam average drainage</p> <p>150 – 350 pumice & soil good drainage</p> <p>350 – 500 fine pumice water table</p>
