Rotorua Lakes Council Wharf and Lakeland Queen Wharf Head Qualitative Assessment

Tonkin & Taylor Ltd. (T+T) has been engaged by Rotorua Lakes Council (RLC) to undertake an independent engineering assessment of the Council Wharf and Lakeland Queen Wharf Head (Berthage). The work was undertaken in accordance with T+T proposal "Rotorua Lakes Council Wharf and Lakeland Queen Berthage Engineering Assessment_v2" dated 17 March 2022.

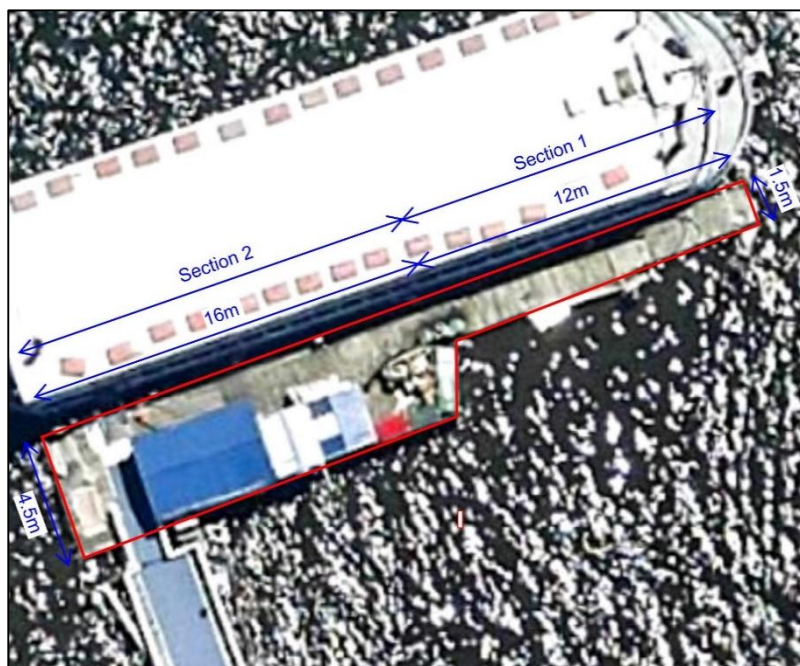
Figure 2.2: Lakeland Queen Wharf Head

The Lakeland Queen Wharf Head can generally be considered in two separate portions (refer to Figure 2.2 for indicative dimensions):

- Section 1 (approximately 12.0m long x 1.5m wide).
- Section 2 (approximately 16.0m long x 4.5m wide).

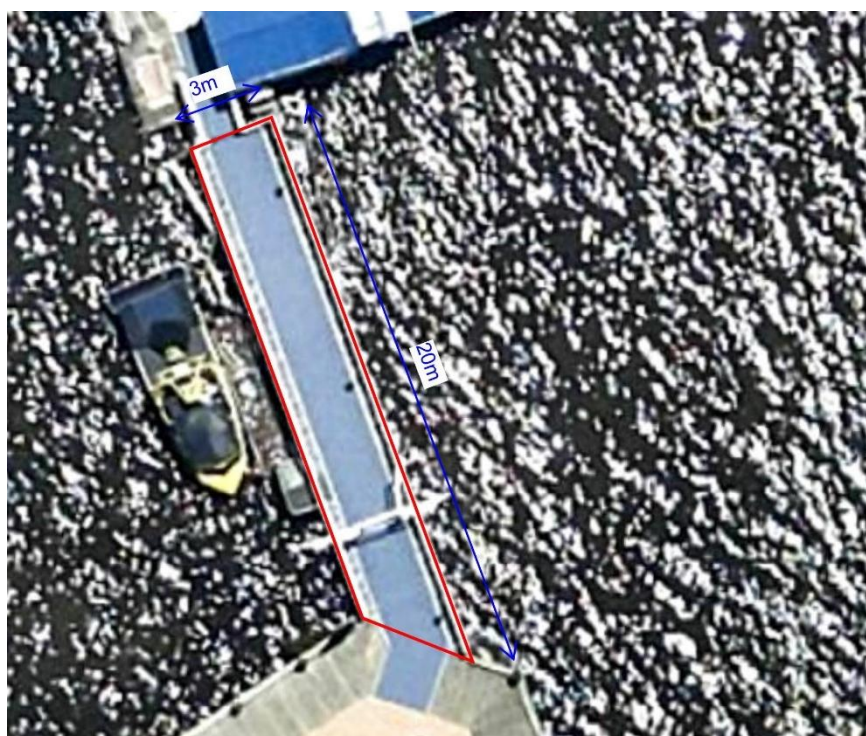
Figure 2.3: RLC Wharf

The RLC Wharf is approximately 20 m long and 3 m wide, and consists of timber bearers, joists and decking supported on timber piles (refer to Figure 2.3 for indicative dimensions).

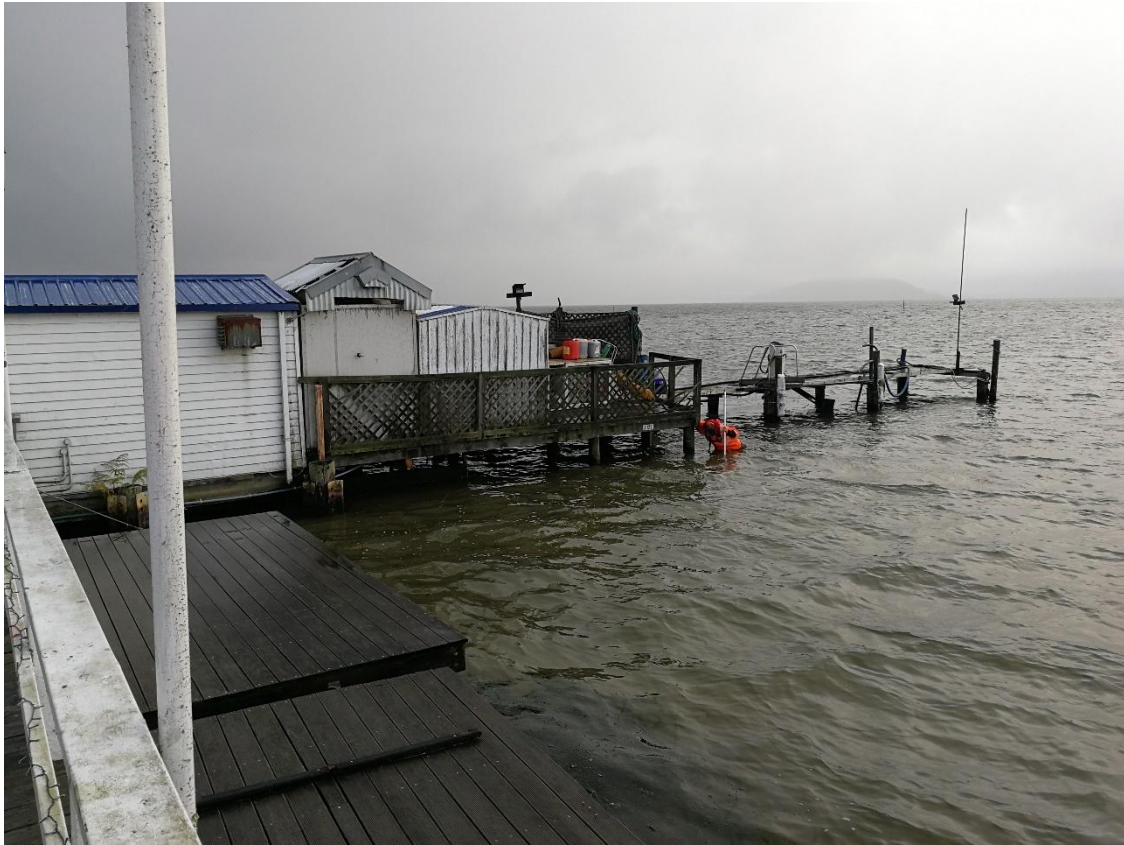
Photograph Appendix A.1: Lakeland Queen Wharf Head

The Lakeland Queen Wharf Head is generally in poor to unsatisfactory condition.

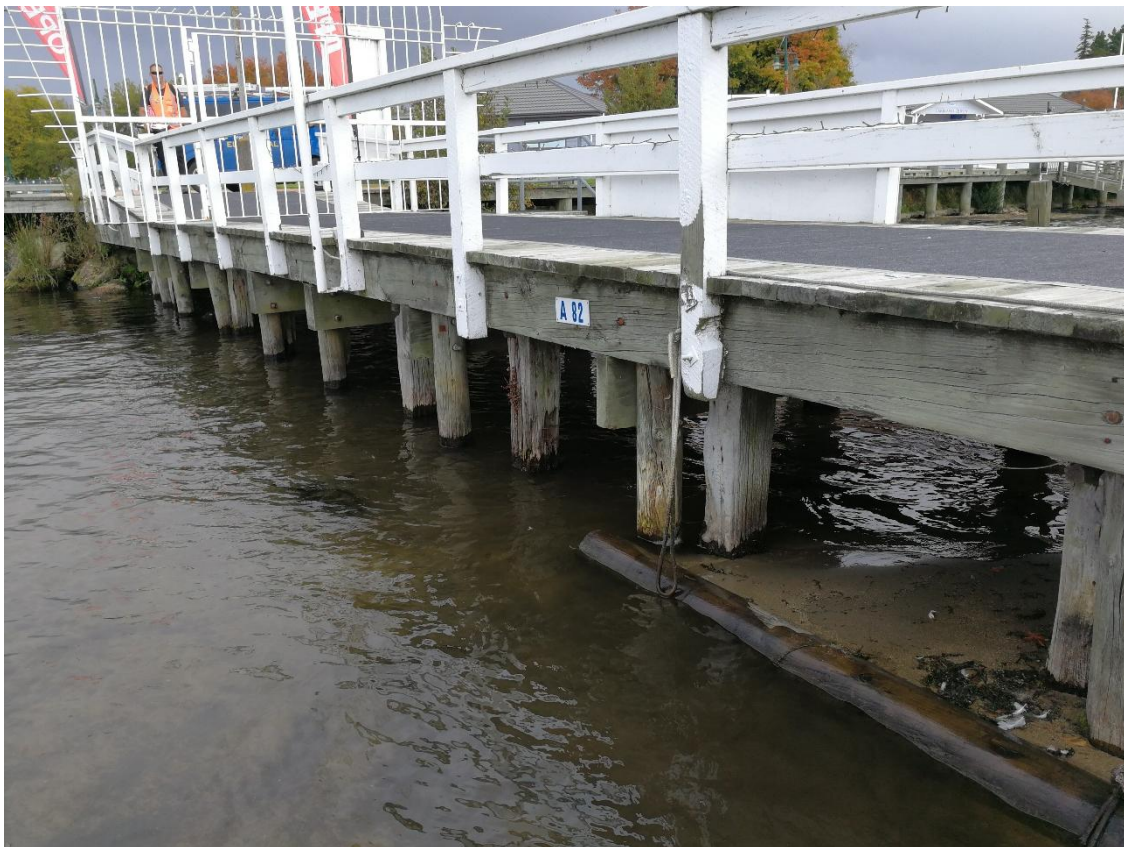
Photograph Appendix A.2: RLC Wharf

The RLC Wharf is generally in fair condition.

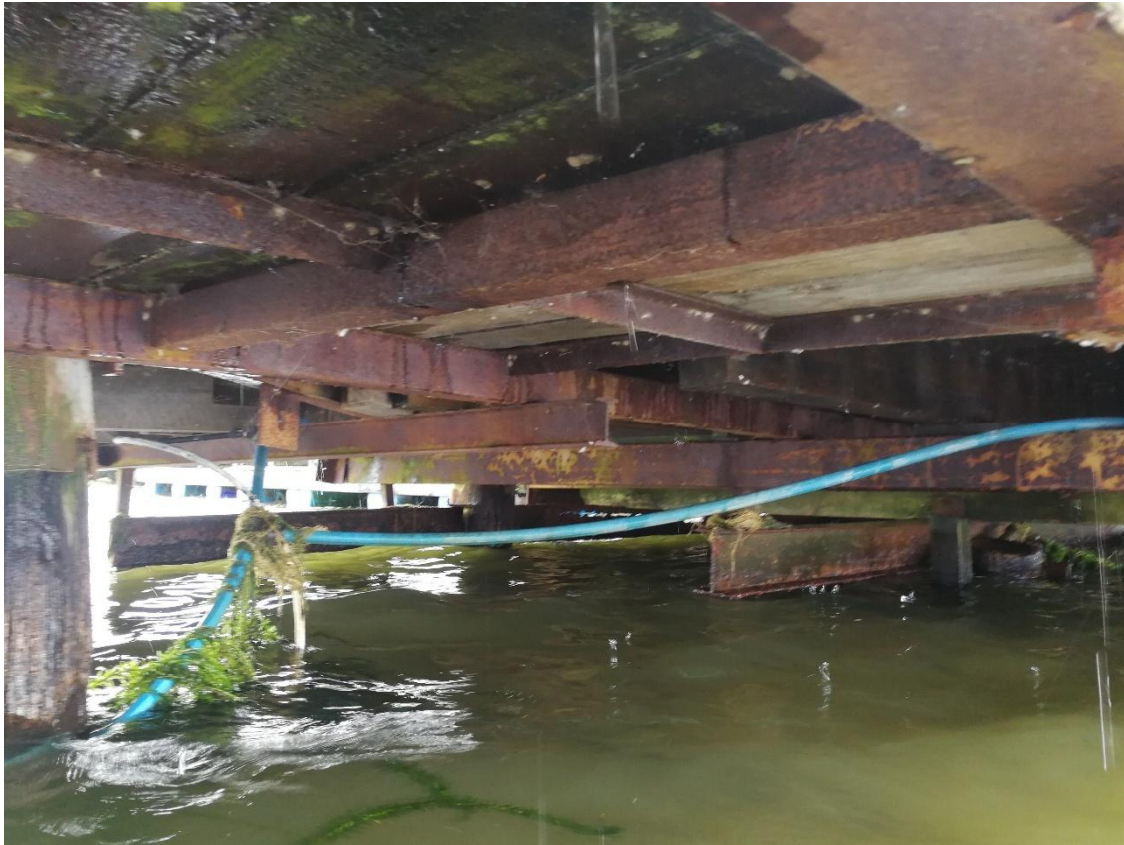
Photograph Appendix A.3: Lakeland Queen Wharf Head support structure- 1

- The wharf head substructure consists of a mixture of steel universal beams, steel hollow sections and timber beams. These members do not appear to follow any specific pattern and appeared to have been installed and replaced on an as needed basis over the years. We have noted areas where improvised measures such as makeshift spacers and additional springs were installed to provide additional support to the decking and mooring pile. Some of these measures did not appear to have been fastened securely and may introduce additional loads to the wharf head:

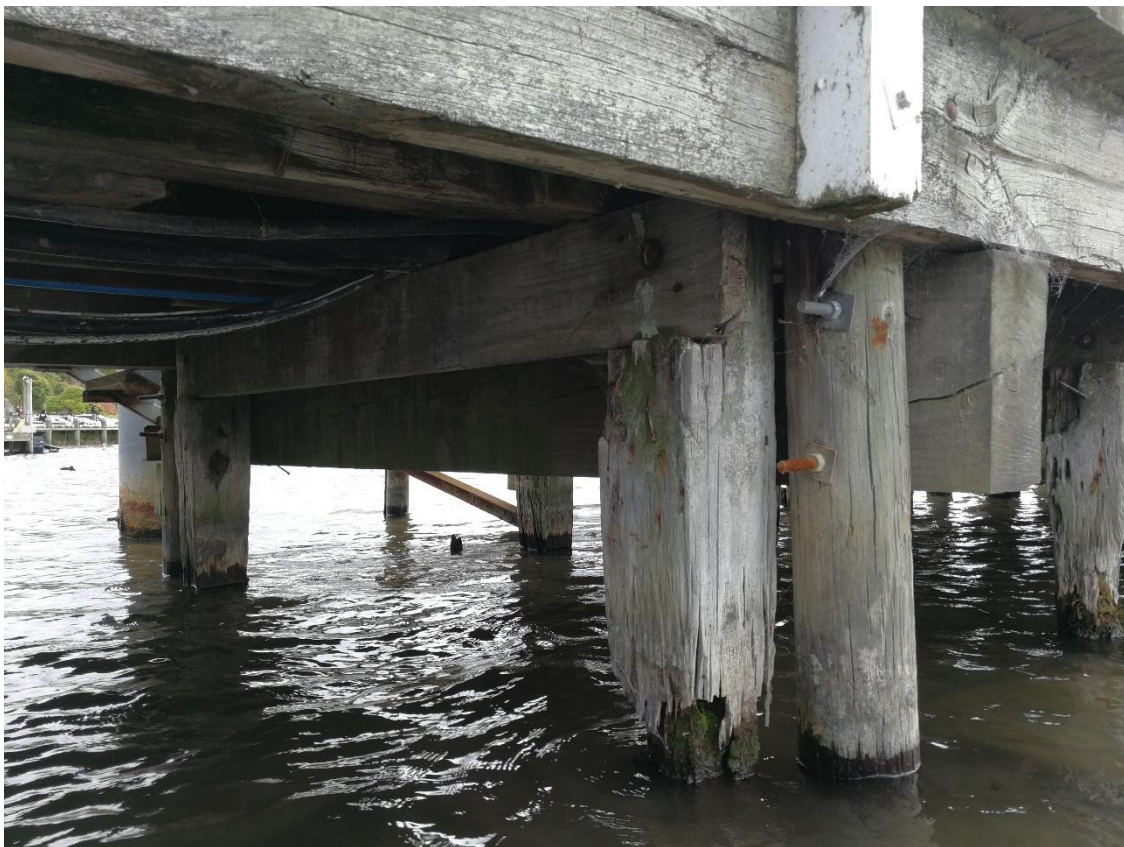
Photograph Appendix A.12: RLC wharf – piles and bearer

- Bolted connections between timber piles and timber bearers are in fair condition. Signs of surface rust on bolts were noted.
